Errata
MSP430F6765 Microcontroller

ABSTRACT

This document describes the known exceptions to the functional specifications (advisories).

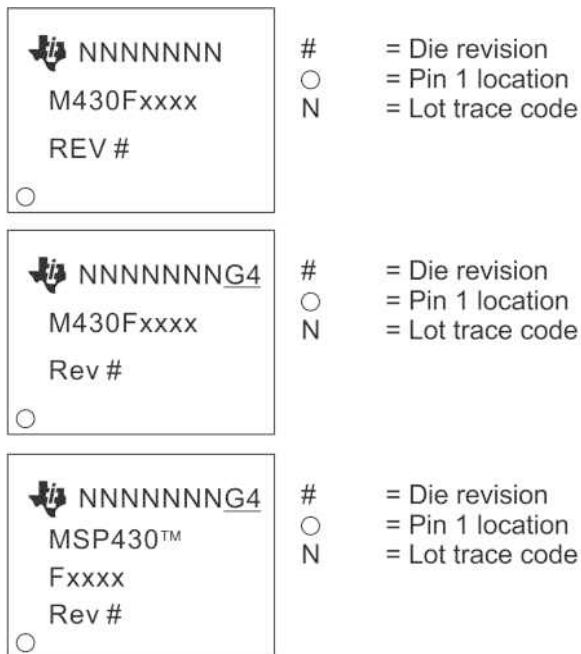
PZ100

LQFP (PZ) 100 Pin

NOTE: Package marking with "TM" applies only to devices released after 2011.
