Errata
MSP430F67651 Microcontroller

This document describes the known exceptions to the functional specifications (advisories).

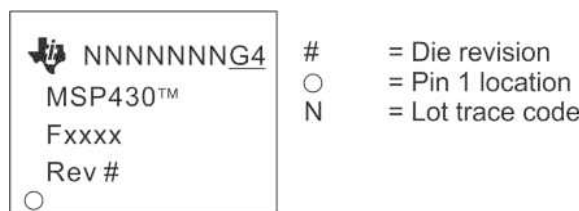
PEU128

QFP (PEU), 128 Pin
