Errata

MSP430F67771 Microcontroller

This document describes the known exceptions to the functional specifications (advisories).

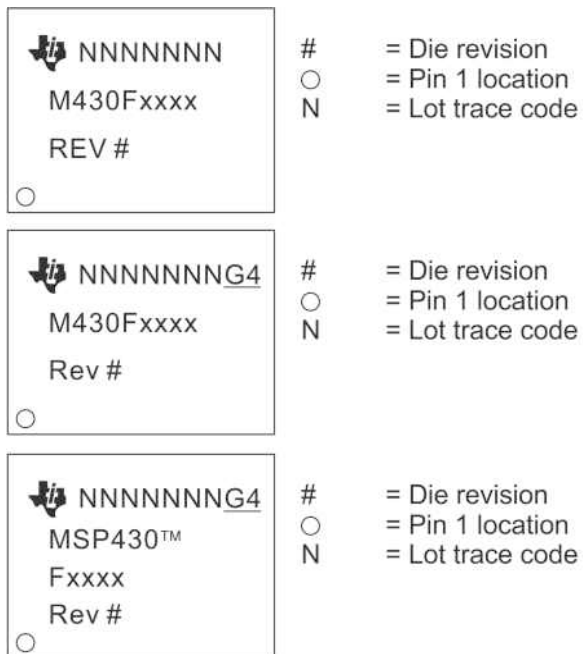
PZ100

LQFP (PZ) 100 Pin

NOTE: Package marking with "TM" applies only to devices released after 2011.
