# Errata

## MSP430F67791 Microcontroller

This document describes the known exceptions to the functional specifications (advisories).

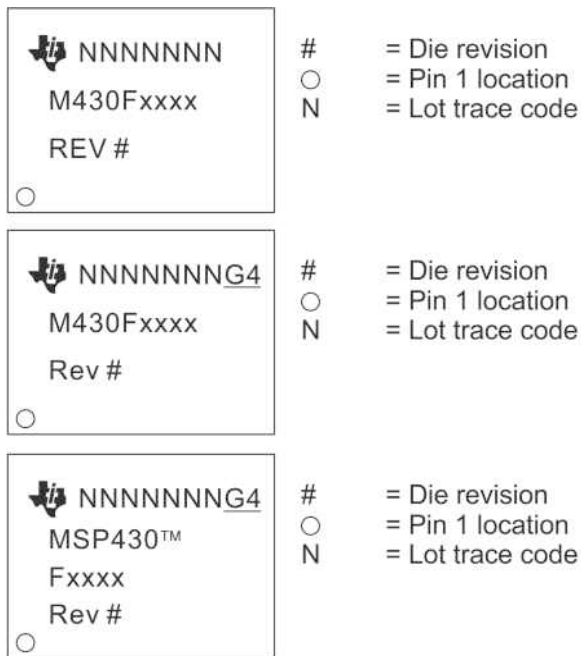
**PZ100**

**LQFP (PZ) 100 Pin**

NOTE: Package marking with "TM" applies only to devices released after 2011.
