ABSTRACT

This document describes the known exceptions to the functional specifications (advisories).

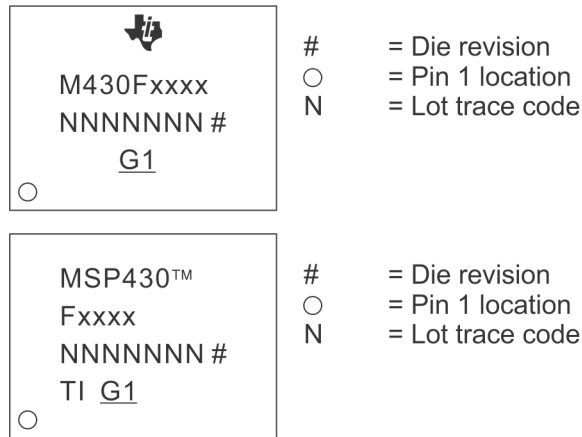
ZQE80

BGA (ZQE), 80 pin

NOTE: Package marking with "TM" applies only to devices released after 2011.

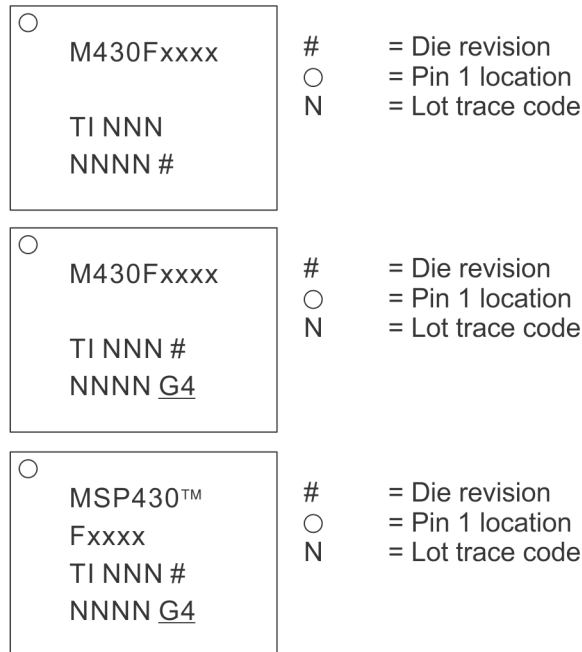
RGC64

QFN (RGC), 64 pin

NOTE: Package marking with "TM" applies only to devices released after 2011.
