**ABSTRACT**

This document describes the known exceptions to the functional specifications (advisories).

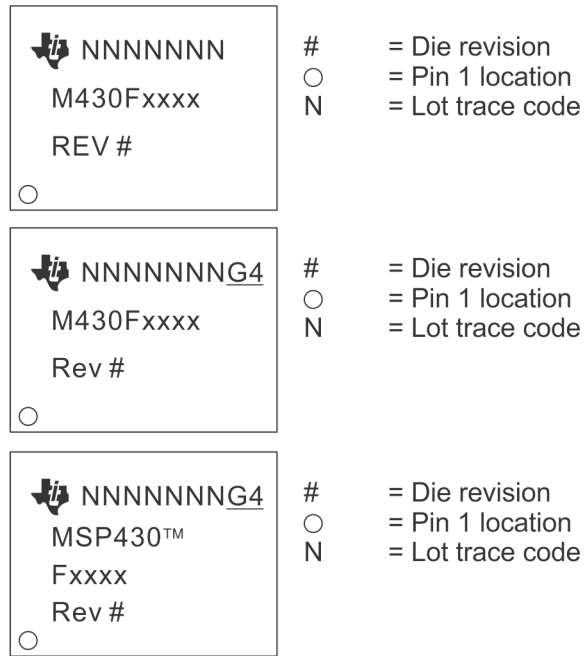
**LQFP (PZ) 100 Pin**

NOTE: Package marking with "TM" applies only to devices released after 2011.
