## ABSTRACT

This document describes the known exceptions to the functional specifications (advisories).

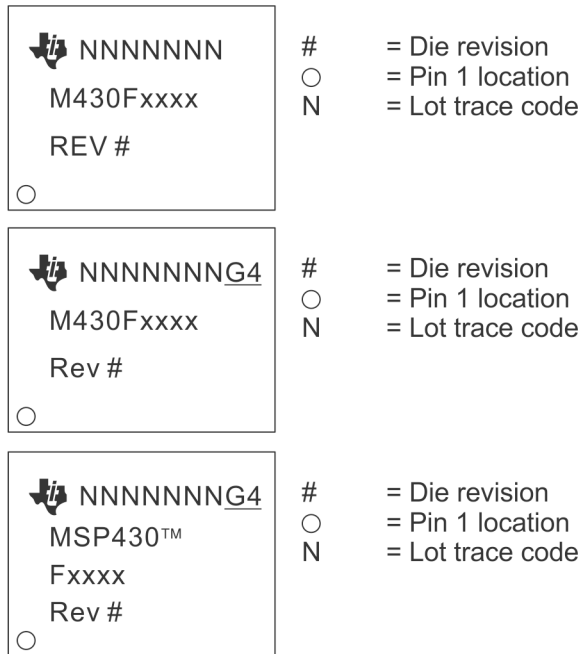
**LQFP (PZ) 100 Pin**

NOTE: Package marking with "TM" applies only to devices released after 2011.
