ABSTRACT

This document describes the known exceptions to the functional specifications (advisories).

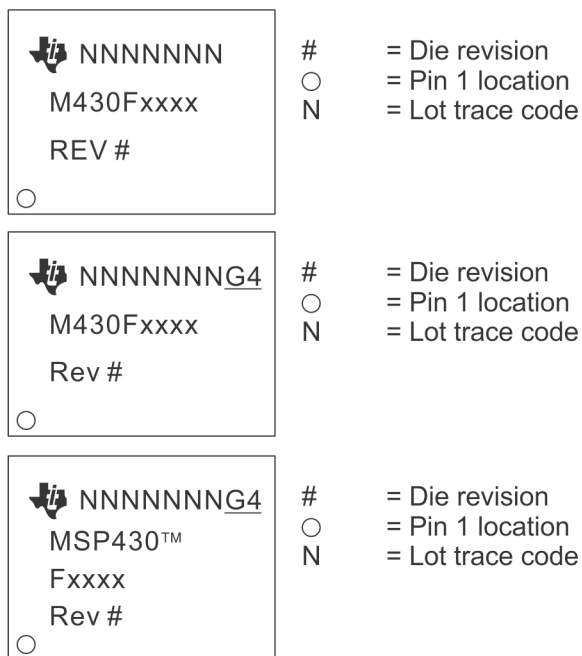
PZ100

LQFP (PZ) 100 Pin

NOTE: Package marking with "TM" applies only to devices released after 2011.
