TMS320LF2402
DSP Controller
Silicon Errata

SPRZ157K
February 2000
Revised July 2003

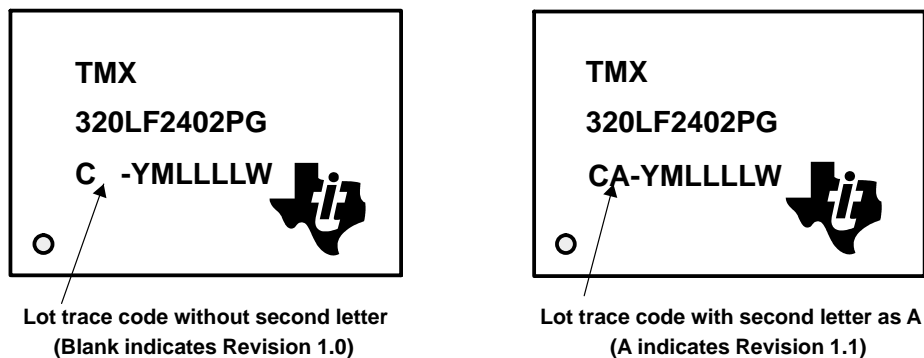
Figure 1. Example, Lot Trace Code for TMX320LF2402 (PG)

The device revision can be determined by the lot trace code marked on the top of the package. The location of the lot trace code for the PG package is shown in Figure 1.

Second Letter in Prefix of Lot Trace Code	Silicon Revision	Comments
Blank (no second letter in prefix)	Indicates Revision 1.0	This silicon revision is available as TMX only.
A (second letter in prefix is an "A")	Indicates Revision 1.1	This silicon revision is available as TMX only.
B (second letter in prefix is a "B")	Indicates Revision 1.2	This silicon revision is available as TMX only.
C (second letter in prefix is a "C")	Indicates Revision 1.3	This silicon revision is available as TMS.
D (second letter in prefix is a "D")	Indicates Revision 1.4	This silicon revision is available as TMS.
F (second letter in prefix is a "F")	Indicates Revision 1.6	This silicon revision is available as TMS.
