TMS320C6414T, TMS320C6415T, TMS320C6416T Digital Signal Processors Silicon Revision 2.0, 1.0

Silicon Errata

Literature Number: SPRZ216J
December 2003–Revised July 2012

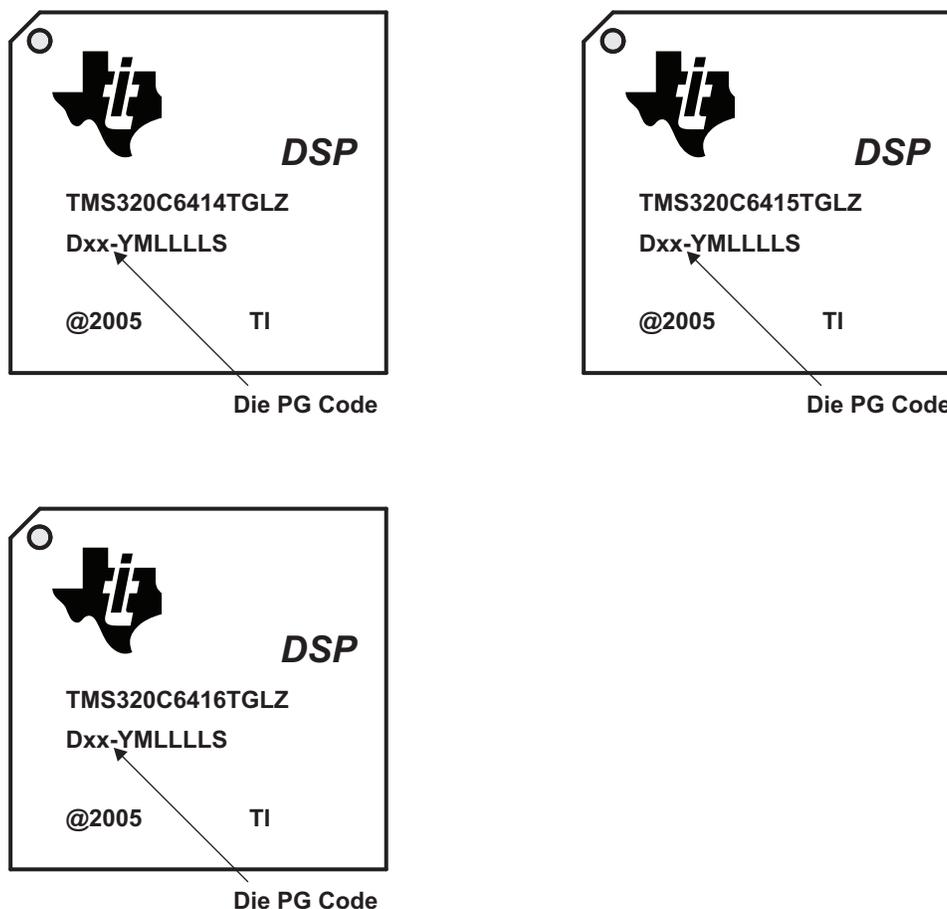
Figure 1. Example, Die PG Codes for TMS320C6414T/C6415T/C6416T (GLZ)

The device revision can be determined by the Die PG code marked on the top of the package. The location of the Die PG code for the GLZ package is shown in Figure 1. Figure 1 shows an example of the types of 6414T, 6415T, and 6416T package symbolization.

- A NOTE: Qualified devices are marked with the letters "TMS" at the beginning of the device name, while non-qualified devices are marked with the letters "TMX" or "TMP" at the beginning of the device name.
