TMS320TCI100Q Digital Signal Processor Silicon Revision 2.0, 1.0

Silicon Errata

Literature Number: SPRZ229F
November 2004–Revised April 2008

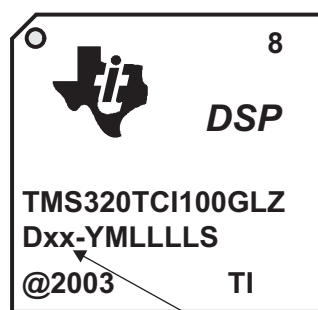
Figure 1. Example, Die PG Codes for TMS320TCI100Q (GLZ)

The device revision can be determined by the die PG code marked on the top of the package. The location of the die PG code for the GLZ package is shown in [Figure 1](#).

Die PG Code

- A Qualified devices are marked with the letters "TMS" at the beginning of the device name, while nonqualified devices are marked with the letters "TMX" or "TMP" at the beginning of the device name.

SEE	ADDITIONS/MODIFICATIONS/DELETIONS
Section 1.2	Revision Identification: Updated Figure 1 , Example, Die PG Codes for TMS320TC1100Q (GLZ)
