AM65x/DRA80xM Processors **Silicon Revision 1.0**

This document describes the known exceptions to the functional specifications (advisories). This document may also contain usage notes. Usage notes describe situations where the device's behavior may not match presumed or documented behavior. This may include behaviors that affect device performance or functional correctness.

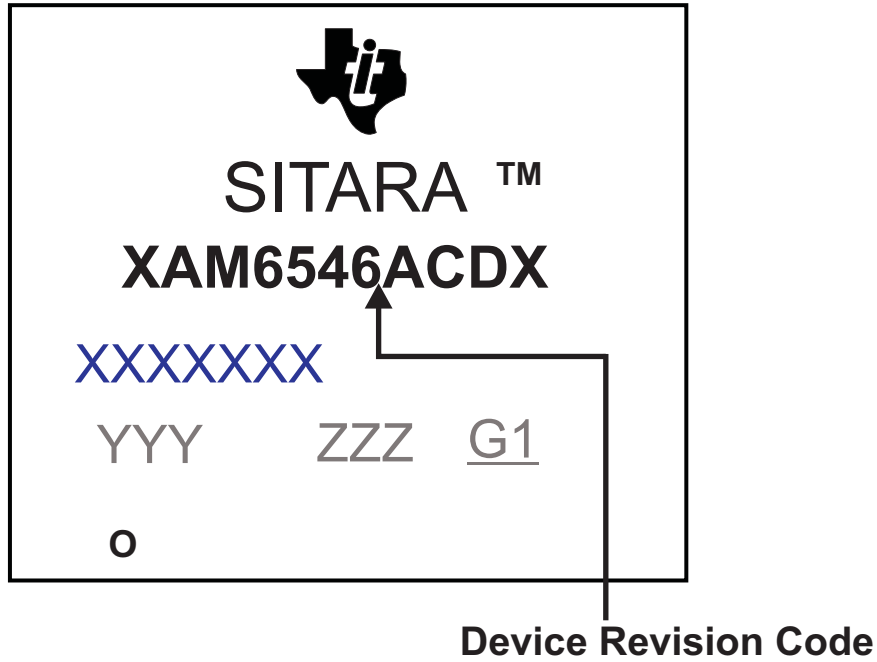
Figure 1. Package Symbolization

Figure 1 shows an example of package symbolization.
