Errata

AMIC120 Sitara™ Processors

Silicon Revision 1.2

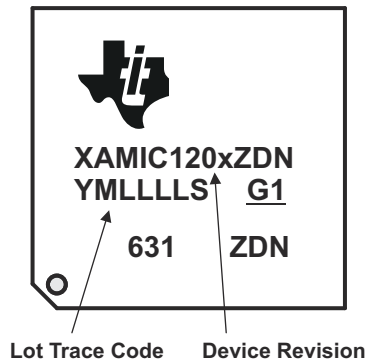
Figure 1-1. Example of Device Revision Codes for the Device Processor

The device revision can be determined by the symbols marked on the top of the package. [Figure 1-1](#) provides an example of the device markings.
