CC1310 SimpleLink™ Ultra-Low-Power Sub-1 GHz Wireless MCU Silicon Revisions B, A

This document describes the known exceptions to functional specifications (advisories) for the CC1310 SimpleLink™ device.

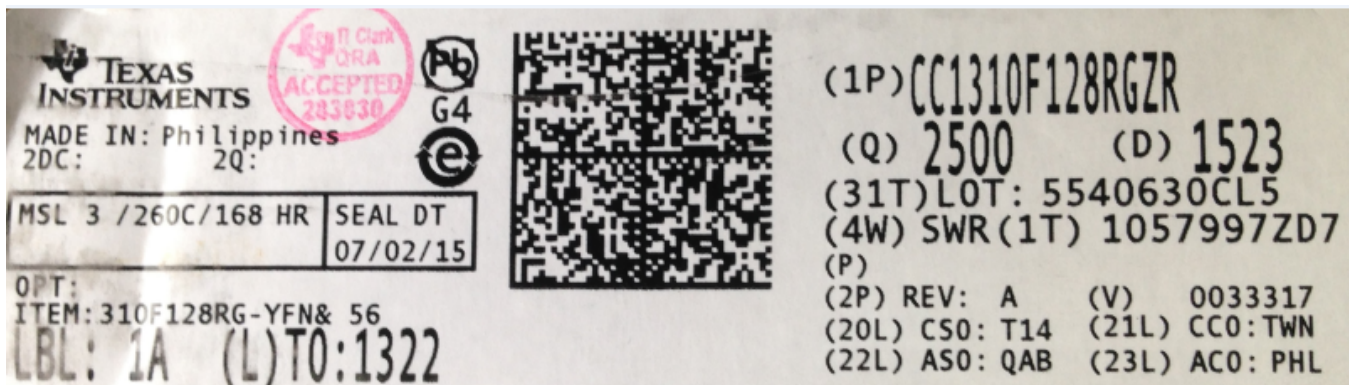
- Package label:
 - The die revision name is shown on the tape and reel label as shown in the example label in Figure 3.
 - Entry (2P) lists the revision (either A or B).

Figure 3. Sample Product Shipping Label for CC1310 Device
