Errata

AWR2243 Device Errata

Silicon Revisions 1.0 and 1.1

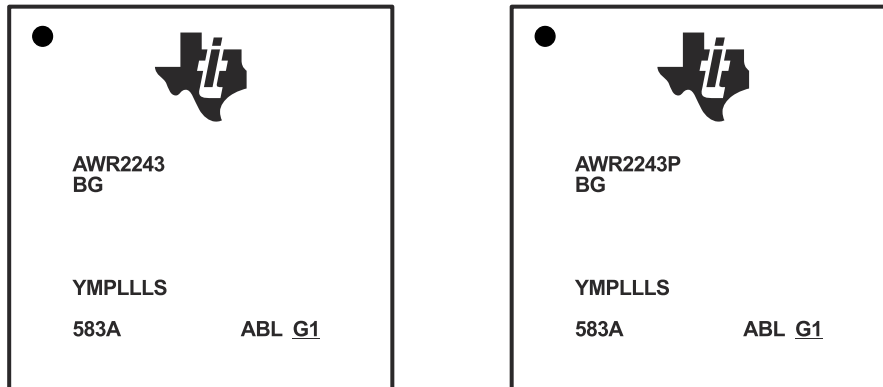
Figure 3-1. Example of Device Part Markings

Figure 3-1 shows an example of the AWR2243 Radar Device's package symbolization.

This identifying number contains the following information:
