# User's Guide

## TI CPSW3G Debug Guide

This application note is a comprehensive debugging guide for the CPSW (common platform switch) peripheral integrated within Texas Instruments' AM2x Sitara™ microcontroller family. Many TI controllers and processors use different variants of the CPSW, such as the CPSW2G, CPSW3G, CPSW5G, CPSW9G, and so forth. The CPSW3G variant is a hardware subsystem on AM26x MCUs from TI that enables high-performance Ethernet connectivity through two external gigabit Ethernet ports and one host port, supporting advanced switching and bridging capabilities essential for industrial communication, real-time networking, time-sensitive networking, and embedded Ethernet applications.

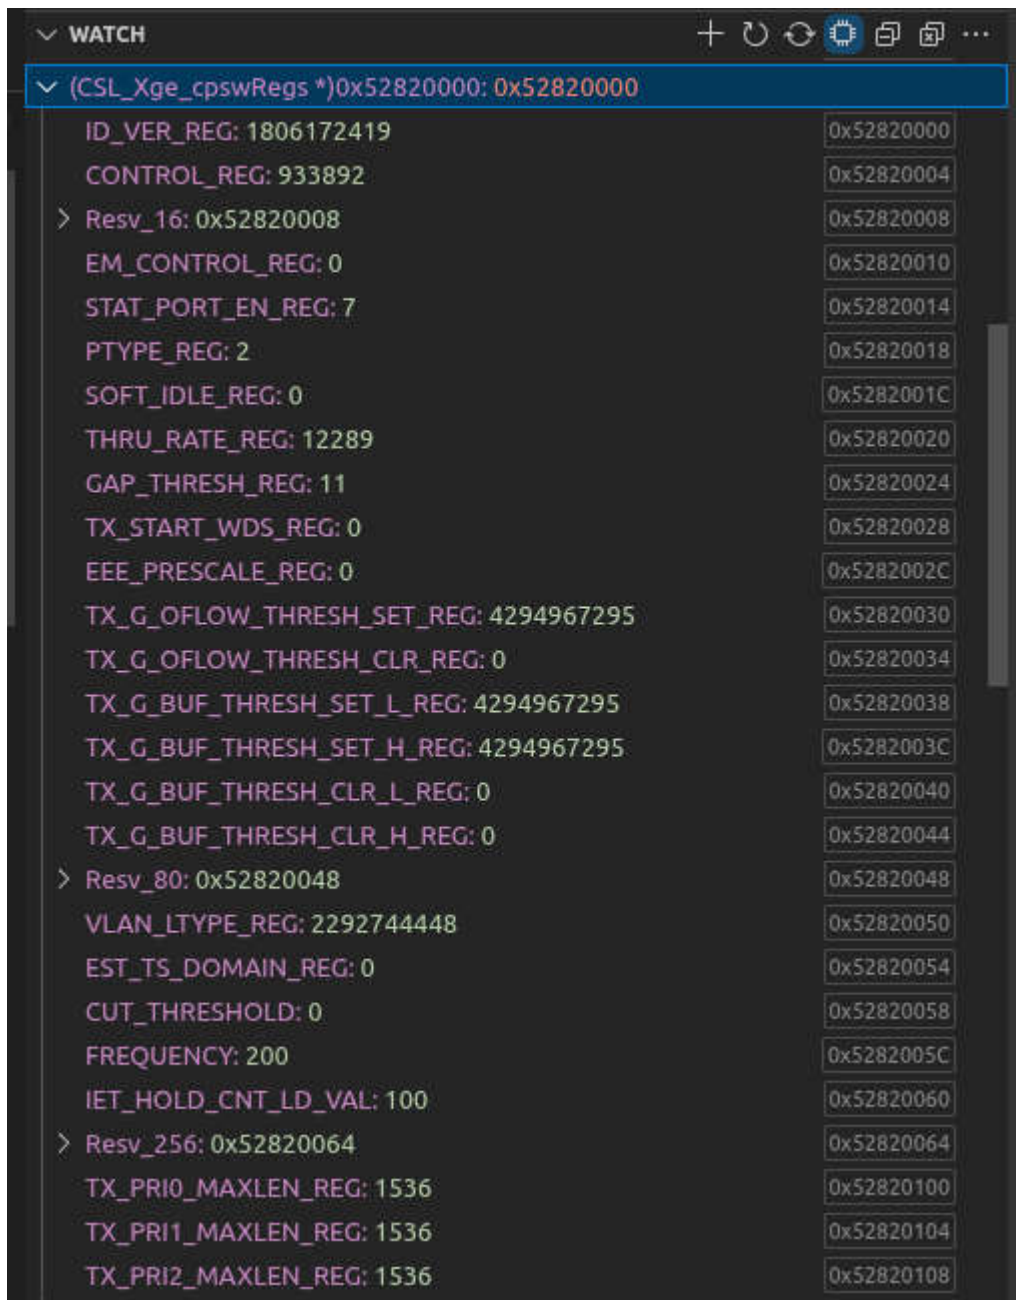
The CPSW statistics can also be viewed directly from the CCS expressions window. Add the following to access the window: (CSL\_Xge\_cpswRegs \*)0x52820000.

**Figure 4-14. CPSW Statistical Expression**
