TMS320F243 and TMS320F241

DSP Controllers

Silicon Errata

Silicon Revision 2.1

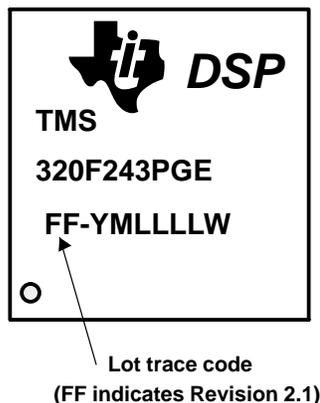
Figure 1. Example, Lot Trace Code for TMS320F243 (PGE)

The device revision can be determined by the lot trace code marked on the top of the package. The location of the lot trace code for the PGE package is shown in Figure 1.

Prefix of Lot Trace Code	Silicon Revision	Comments
FF	Indicates Revision 2.1	This silicon revision is available as TMS.
