ABSTRACT

This document describes the known exceptions to the functional specifications (advisories).

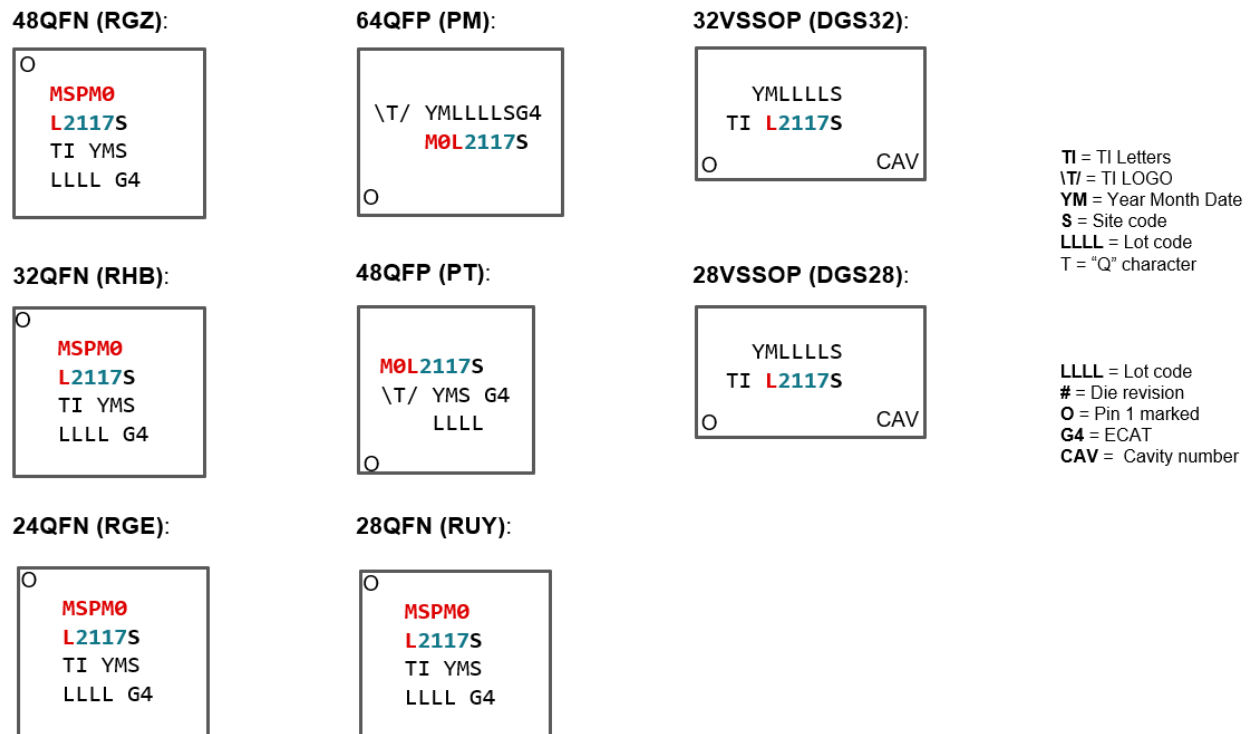
Figure 5-1. Package Symbolization

The package diagrams below indicate the package symbolization scheme, and [Figure 5-1](#) defines the device revision to version ID mapping.
