## ABSTRACT

This document describes the known exceptions to the functional specifications (advisories).

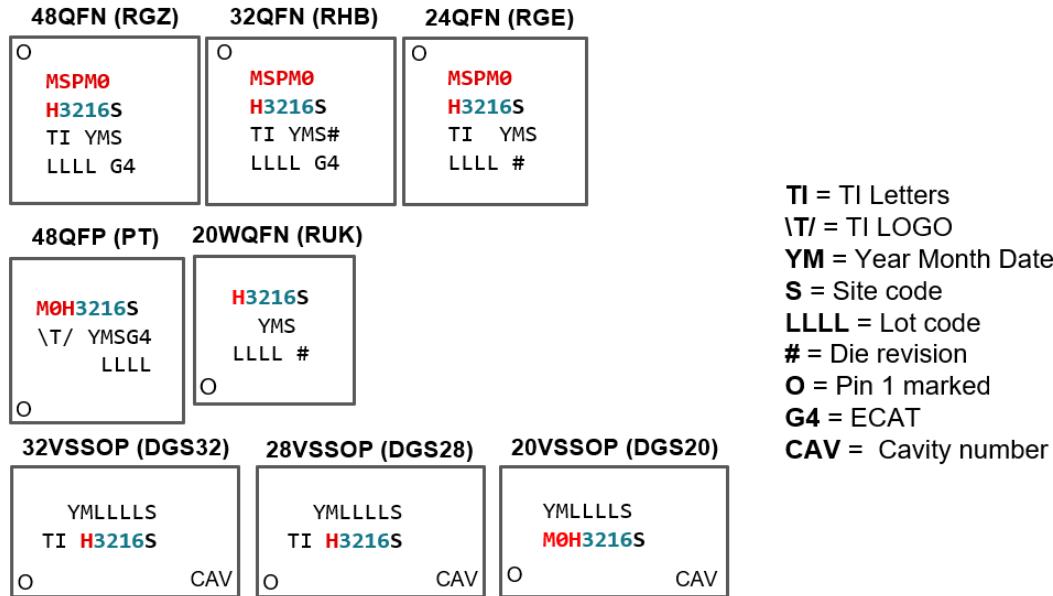
**Figure 5-1. Package Symbolization**

The package diagrams below indicate the package symbolization scheme, which is the RTM version. And [Table 5-1](#) defines the device revision to version ID mapping.
